## **TECH FILE: #1**

### **BOSCH IGNITION MODULE CONVERSION**

By Merlin.

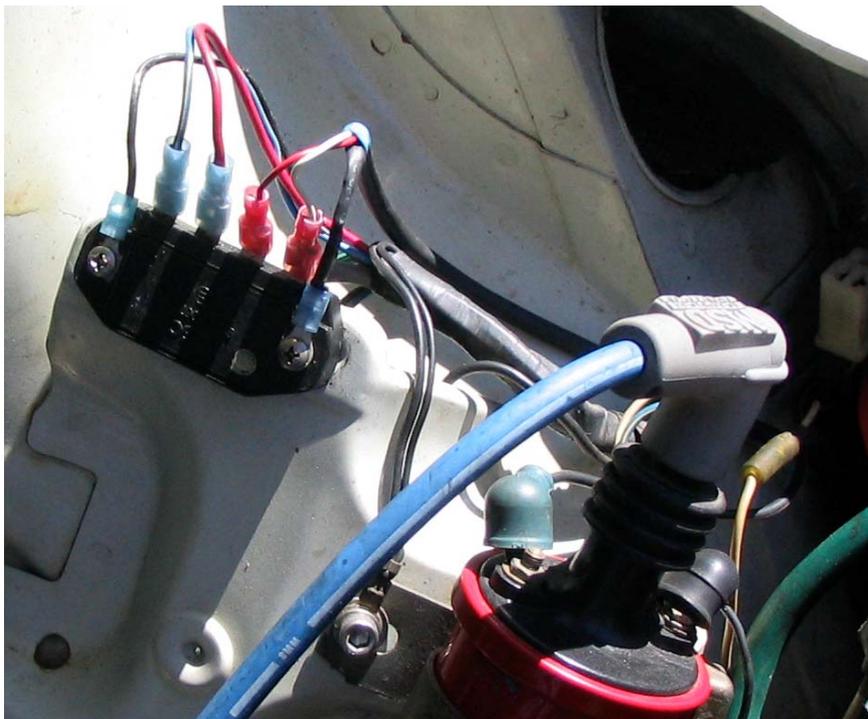
FIG.1 BOSCH IGNITER MOUNTED IN THE FACTORY IGNITER POSITION

Mount the Bosch igniter module as shown in FIG 1. It does require heat-sinking and good ground connections to the chassis on the mounting screws.

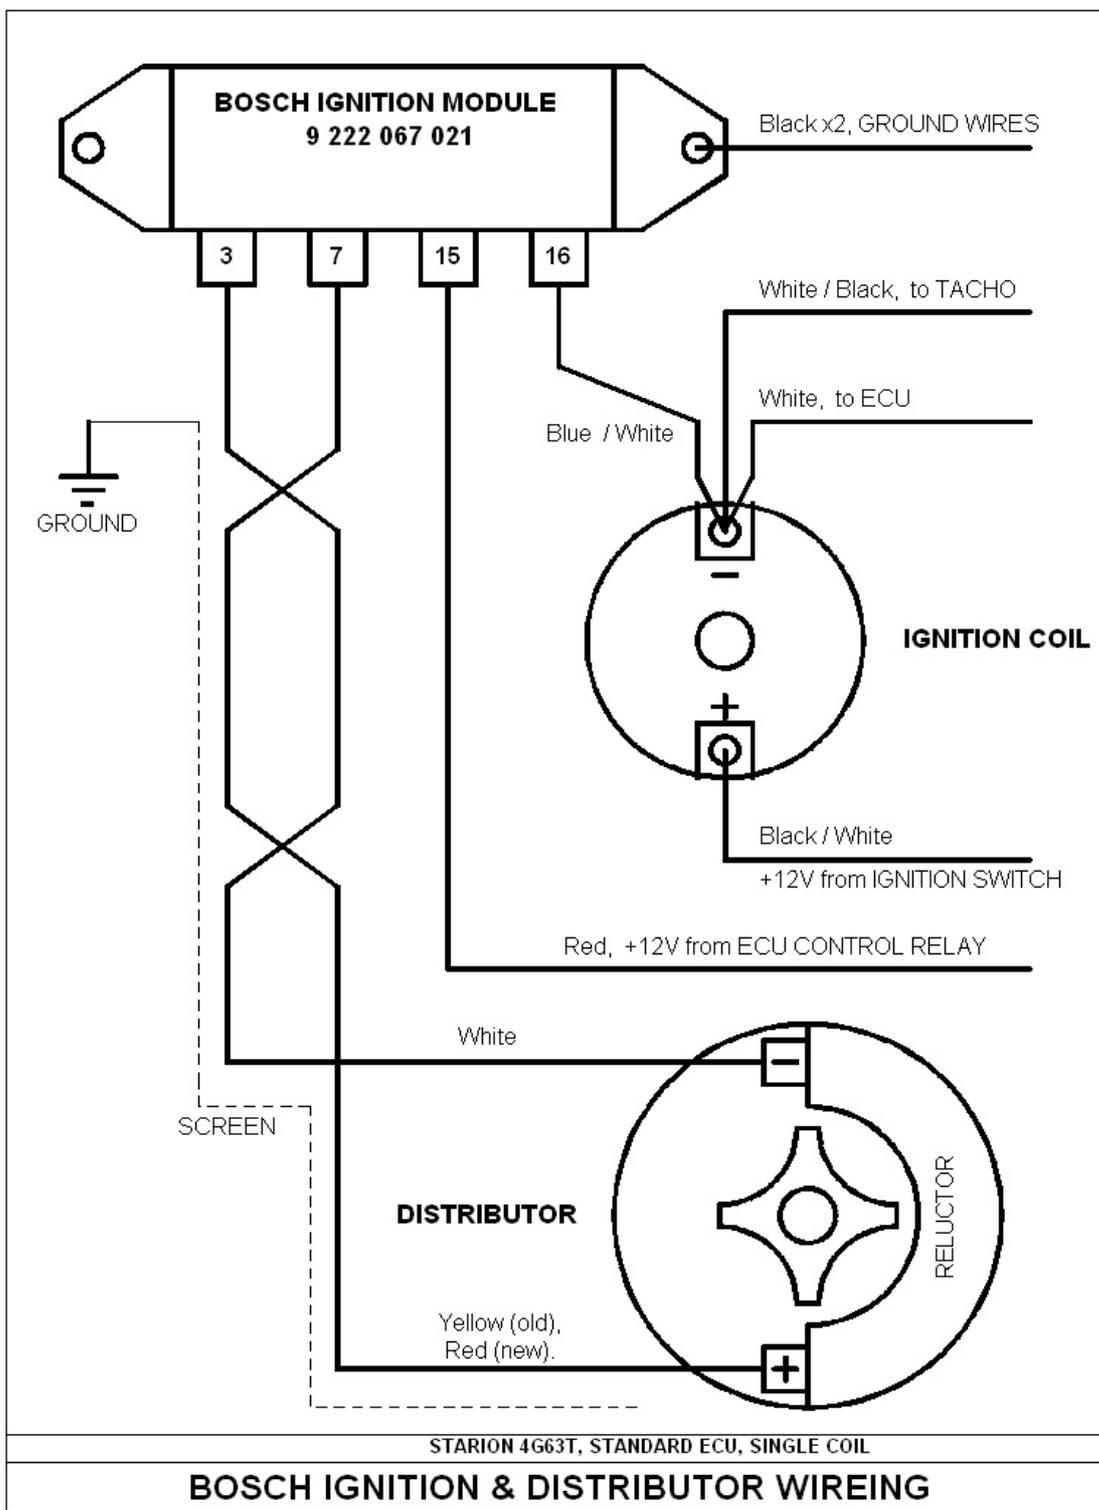
Note: The factory distributor signal cable has been replaced with a new screened twisted pair cable, with red and white cores. The cable screen should be connected to ground at the igniter module. The original connections to the Reluctor had deteriorated and required replacement.

Wire the igniter module to the distributor and coil as shown in FIG 2.

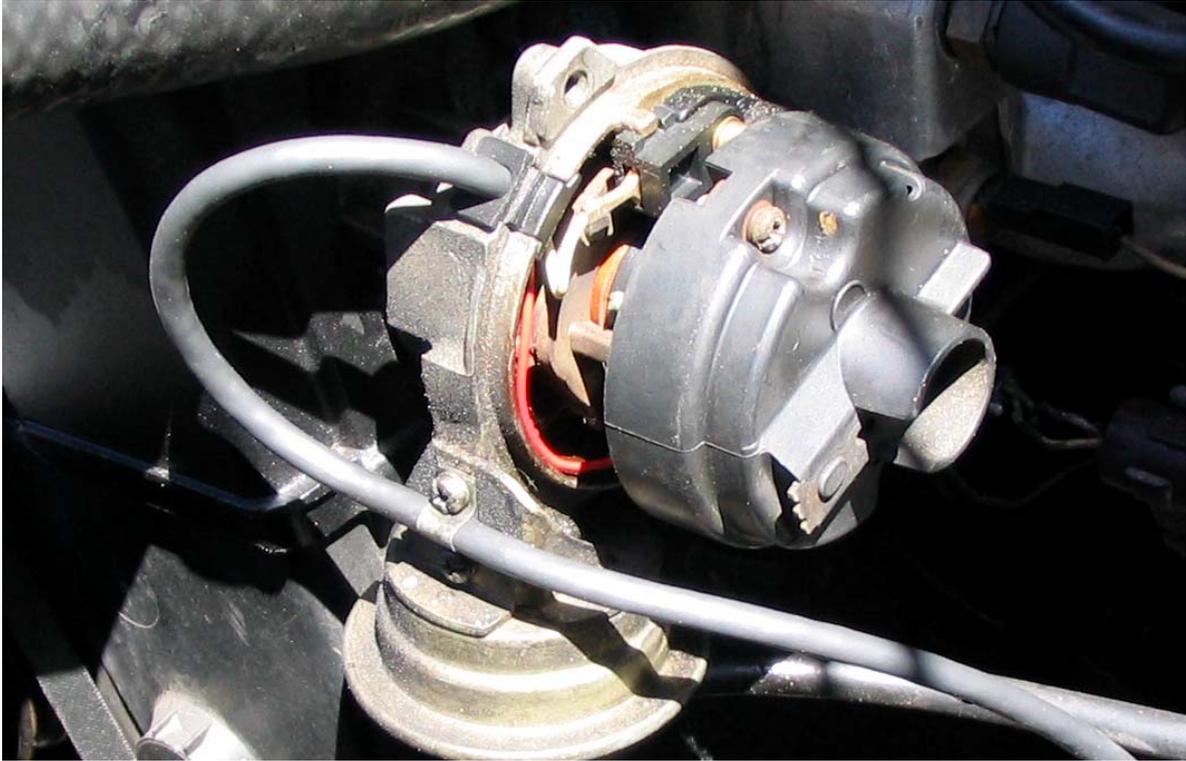
The Reluctor wiring can be seen in FIG 3 below. Note the negative side wire is at the top. The cable hole in the rubber grommet had to be opened up to fit the new cable, which was heat hardened and very brittle. The spade connectors to the Reluctor were loose enough to cause intermittent ignition failure.

FIG 3. RELUCTOR WIREING with DISTRIBUTOR CAP REMOVED
